Report No. UT-03.15

***SEISMIC REHABILITATION
OF CONCRETE BRIDGES:
VERIFICATION USING IN-
SITU TESTS AT SOUTH
TEMPLE BRIDGE ON
INTERSTATE 15***

Final Report

**Utah Department of Transportation
Research Division**

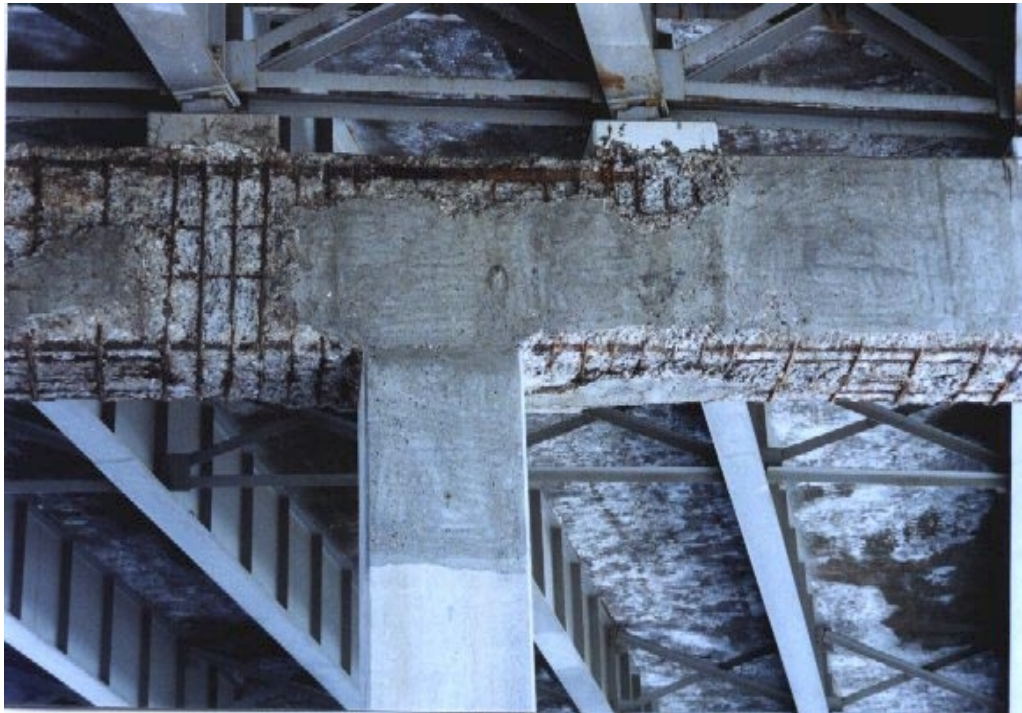
The amount of corrosion of the reinforcement is important for evaluating the remaining capacity of bridge bents. At the South Temple Bridge site, all of the beam caps had some corrosion, including the bents to be tested, as well as those that were not tested as part of this research. There was no obvious sign of corrosion in the columns of Bents #5 and #6. It is interesting that the majority of the observed corrosion occurred in the stirrups of the beam cap. There was only one observed occurrence of corrosion in the longitudinal column bars at one of the joints of Bent #6, as shown in Fig. 6. The diameter of the bar, which was originally 31 mm, was reduced to 30 mm. It should be noted, that the corrosion was visible at the north, south and bottom sides of the beam caps, where the concrete had spalled. Corrosion was present at the topside of the beam cap; however, the concrete was still in place and only after removal of the concrete cover with hydro blasting was the corrosion visible.

Figure 6. Corrosion in the beam cap of Bent #6

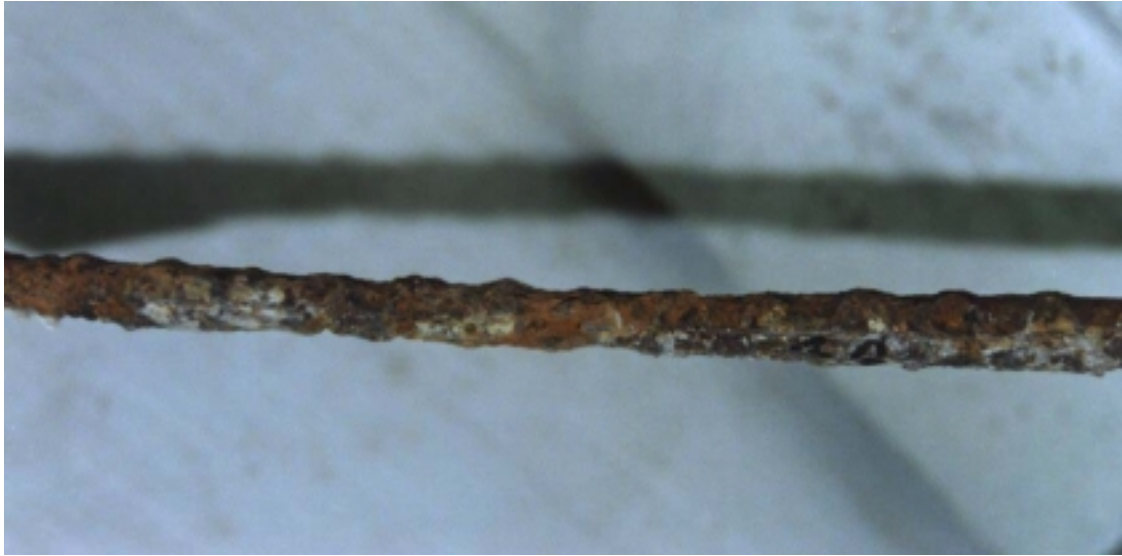
An analysis of the corrosion level is presented in what follows. The condition of a typical corroded bar is shown in Fig. 7.

Figure 7. Close-up of corroded rebar from Bent #6

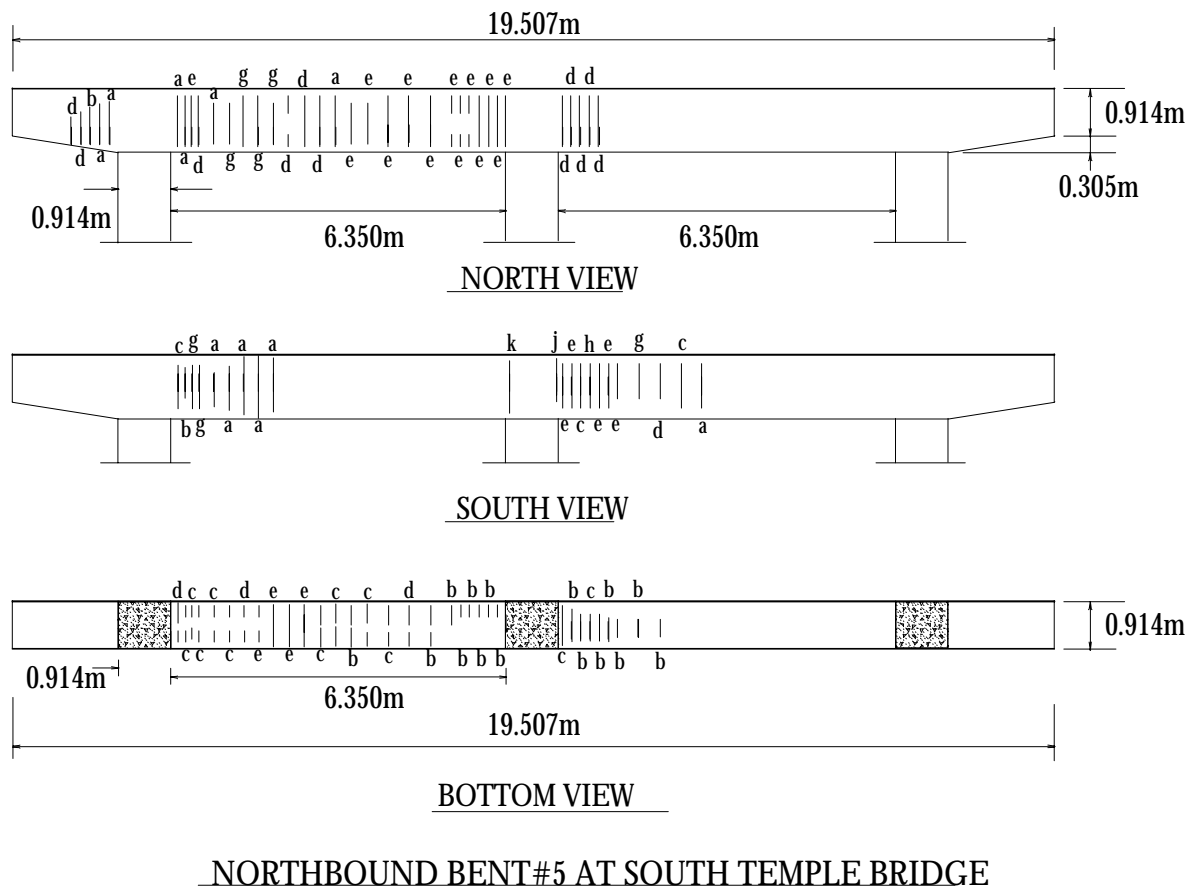
Figure 8. Corrosion map for Bent #5

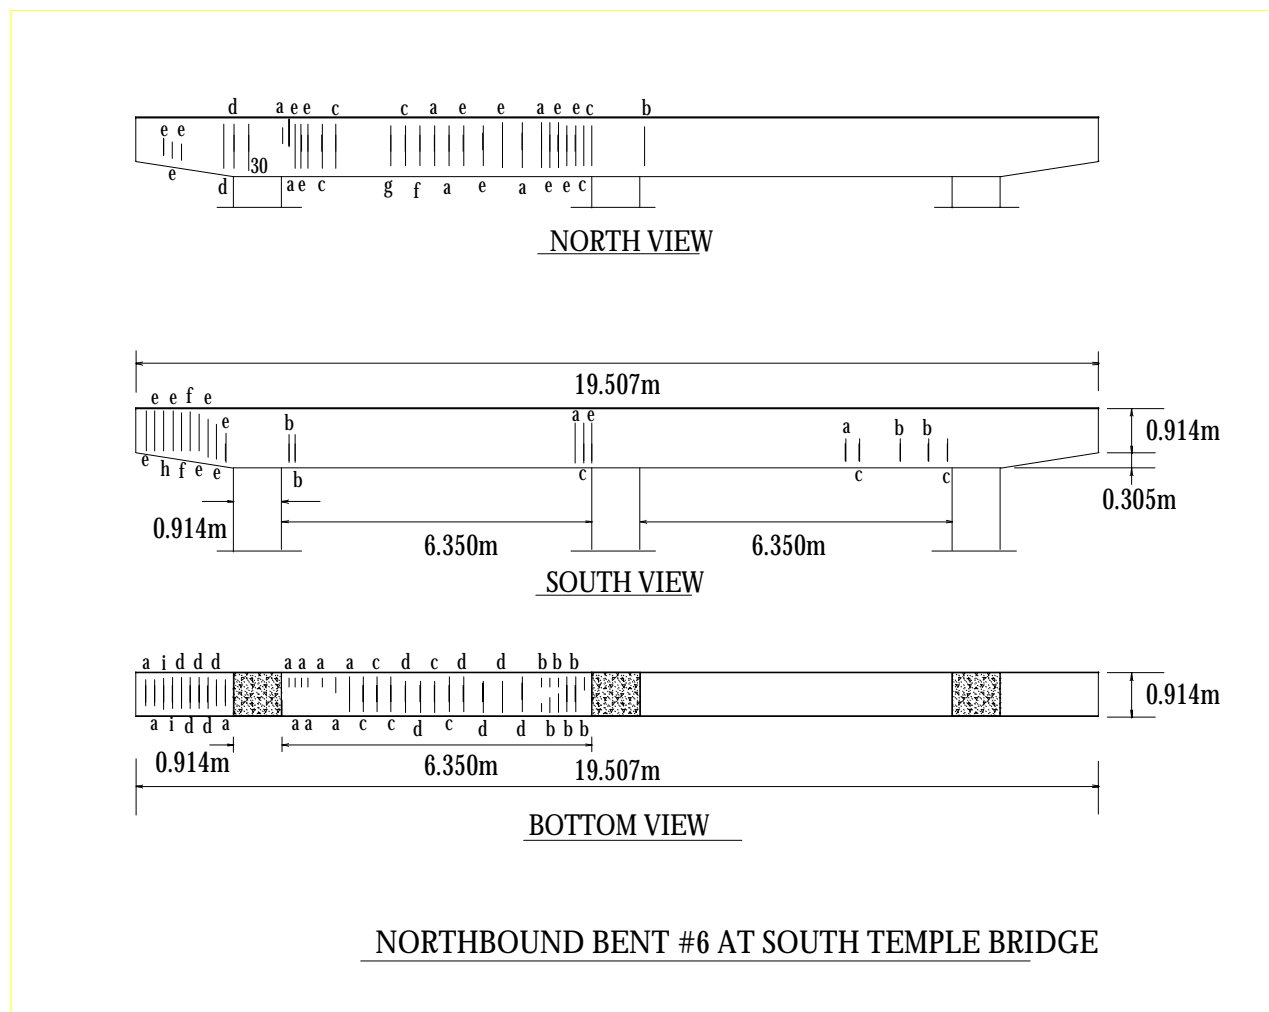
Figure 9. Corrosion map for Bent #6

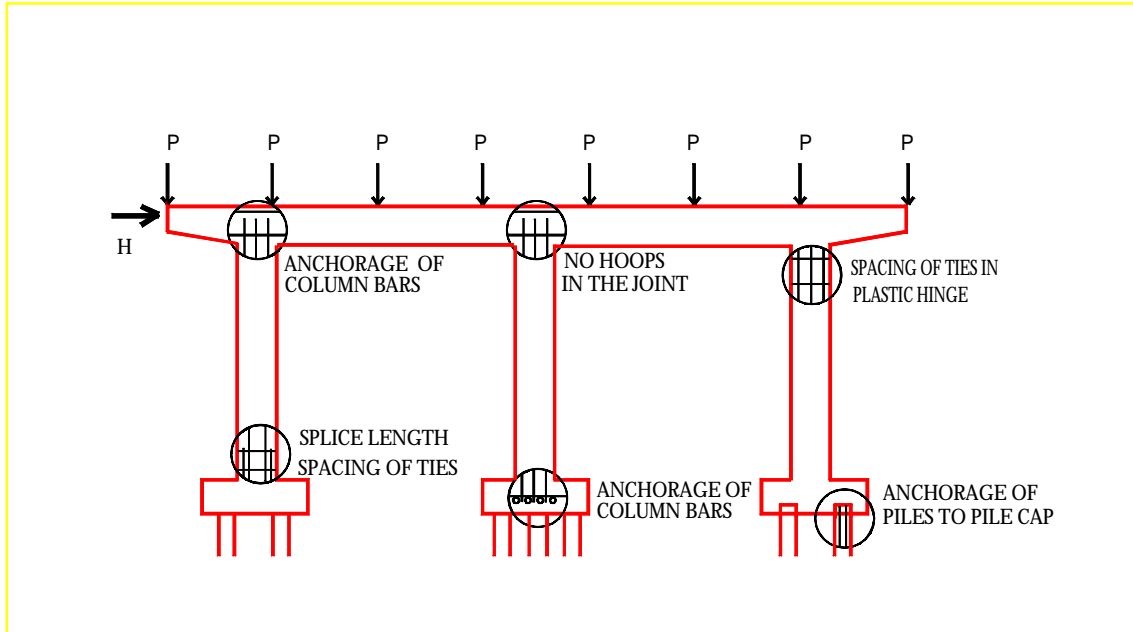
By performing a static pushover analysis for the bent, an estimate of the peak lateral load and the maximum horizontal displacement were determined. The yielding sequence of the structural members was observed, and member forces were calculated at the ultimate displacement. This information was necessary for the rehabilitation design of Bent #6 using FRP composites. To construct the 2-D model of the structure, the existing conditions had to be evaluated and compared with the original design plans. The reinforcement details of the bent were presented in Fig. 4; the columns had a reinforcement ratio of 1.6%. It can be seen that the column transverse reinforcement was inadequate in the lap-splice region, and the anchorage of the longitudinal reinforcement in the pile cap and in the cap joint was insufficient. In addition, there are no transverse hoops in the column cap-beam connection. Since the lap splice in the column base is mostly unconfined, it would break down under cyclic inelastic action. The spacing of ties in the plastic hinge region at the top of the columns was insufficient. In addition, the anchorage of the piles into the pile cap was insufficient. These deficiencies are identified in Fig. 24.

Figure 24. Reinforcement details showing deficiencies of Bent #5 for resisting large earthquakes

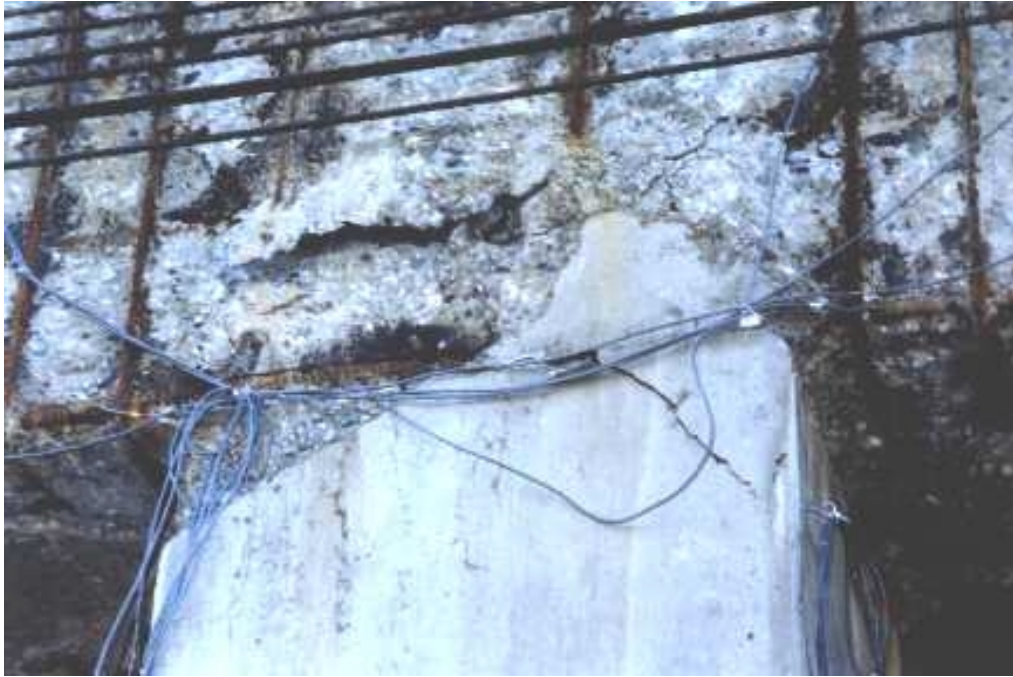
Significant diagonal tension cracks formed in the beam cap-column joint region, revealing a gradual degradation of the concrete as shown in Fig. 33. After the test, the loose concrete was removed from the joint, and it was apparent that there was not much left from the outside 100 mm (3.9 in.) to 150 mm (5.9 in.) layer. Flexural cracks developed at the top of the columns that opened as the bending capacity was reached. These cracks had various widths with the largest being at the interface of the column and the beam cap, which reached approximately 2 mm (3/32 in.) as shown in Figs. 33-35. The cracks went all around the column perimeter in the plastic hinge region. The first layer of the column longitudinal reinforcement extending into the joint was exposed on

Figure 33. Damage in the interior joint of Bent #5

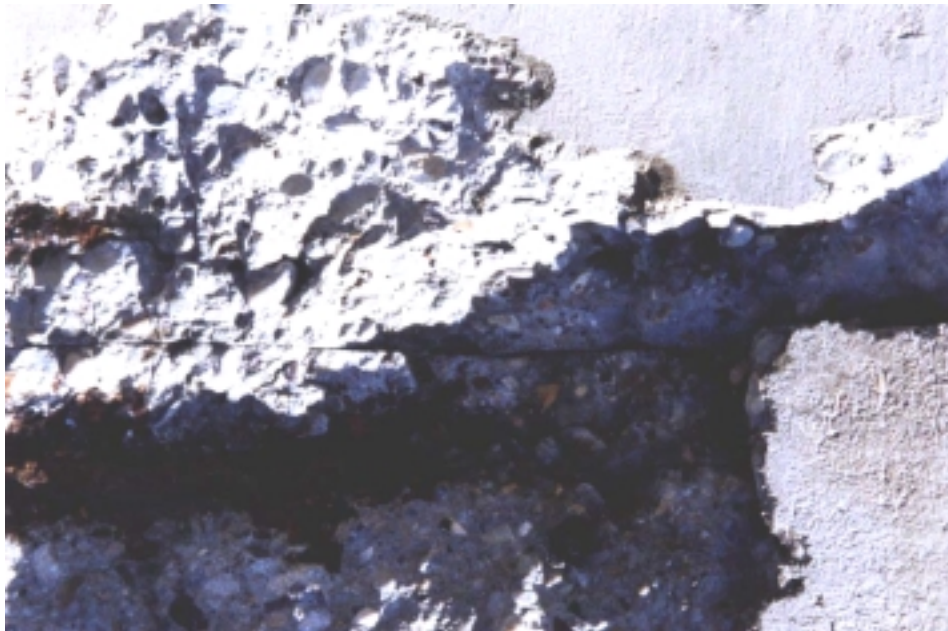
Figure 34. Close up of beam cap – column joint on Bent #5

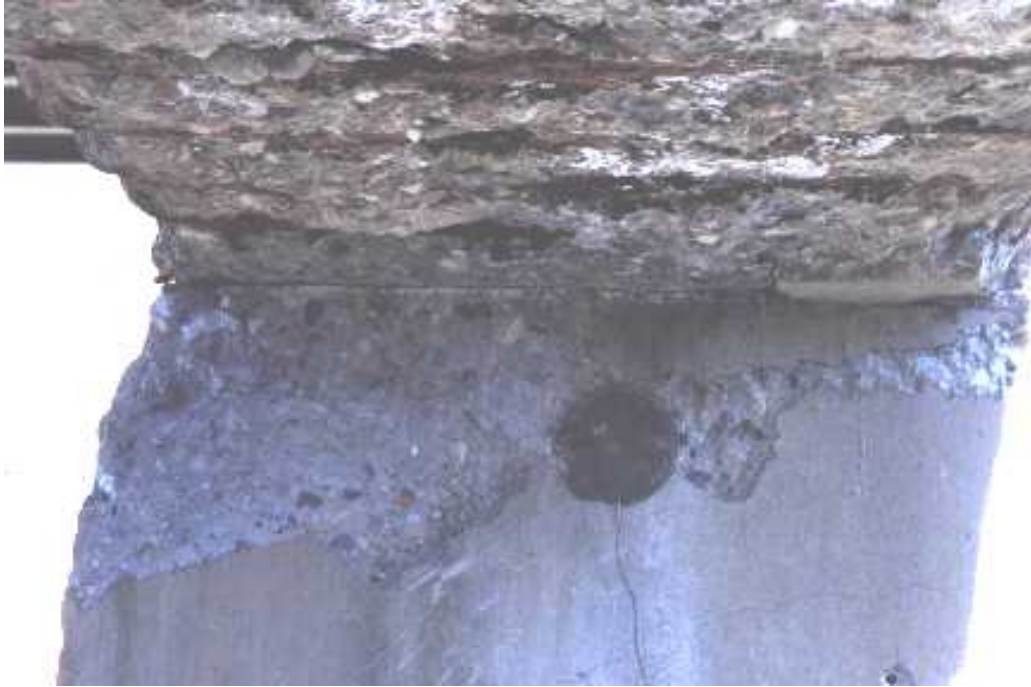
Figure 35. Damage at the beam cap – column joint of the interior column of Bent #5

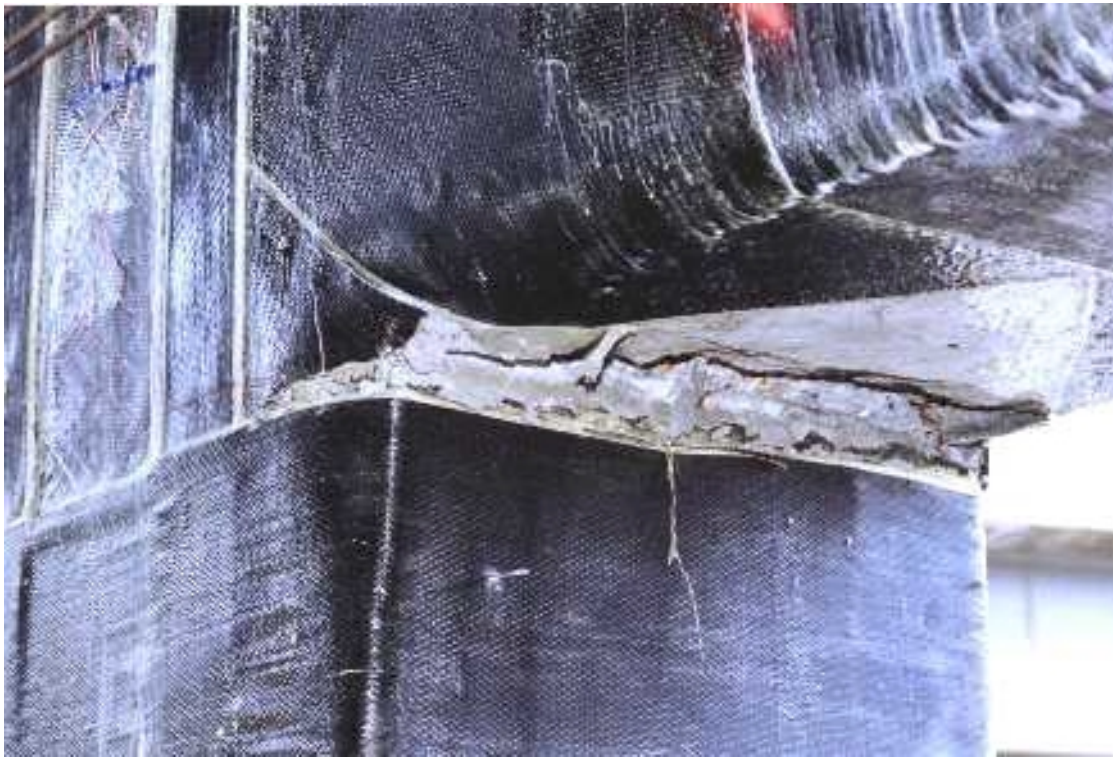
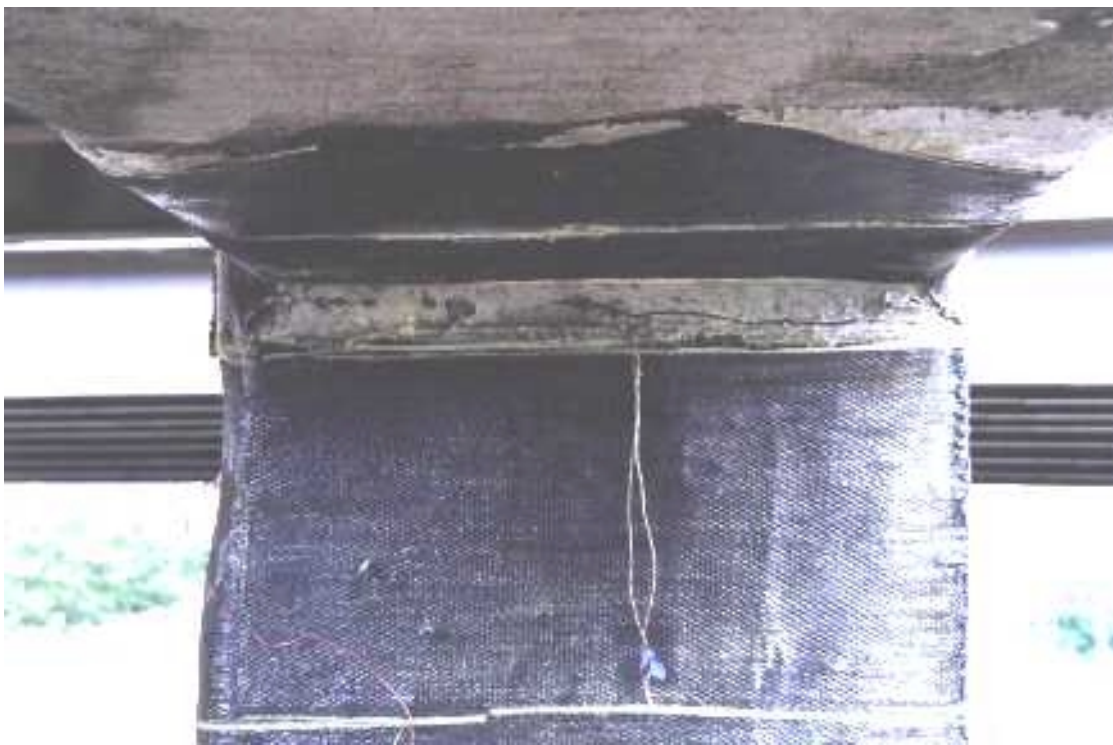
Large cracks in the concrete were visible at the interface between the column and the beam cap, which reached 6 mm in width as shown in Fig. 65. These interface cracks propagated from the concrete into the FRP composite as shown in Fig. 66. In addition, at both column ends, shallow spalling cracks in the 51 mm gaps were formed. The FRP advanced composite layers

Figure 65. Cracking at the beam cap-column interface of Bent #6

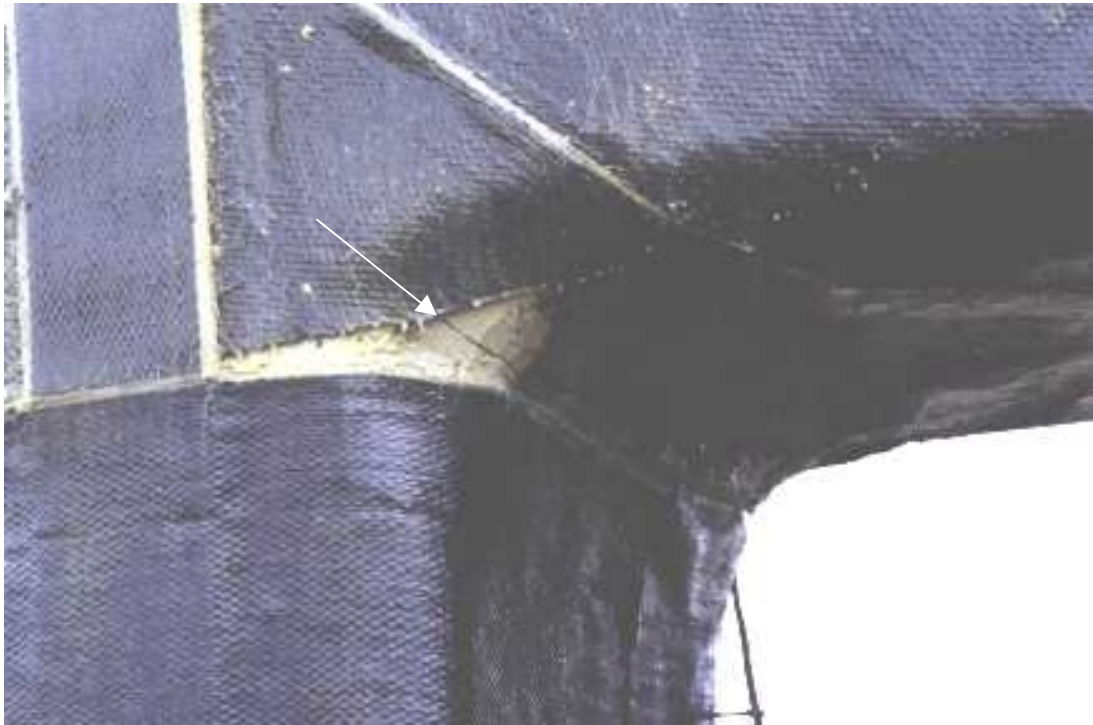
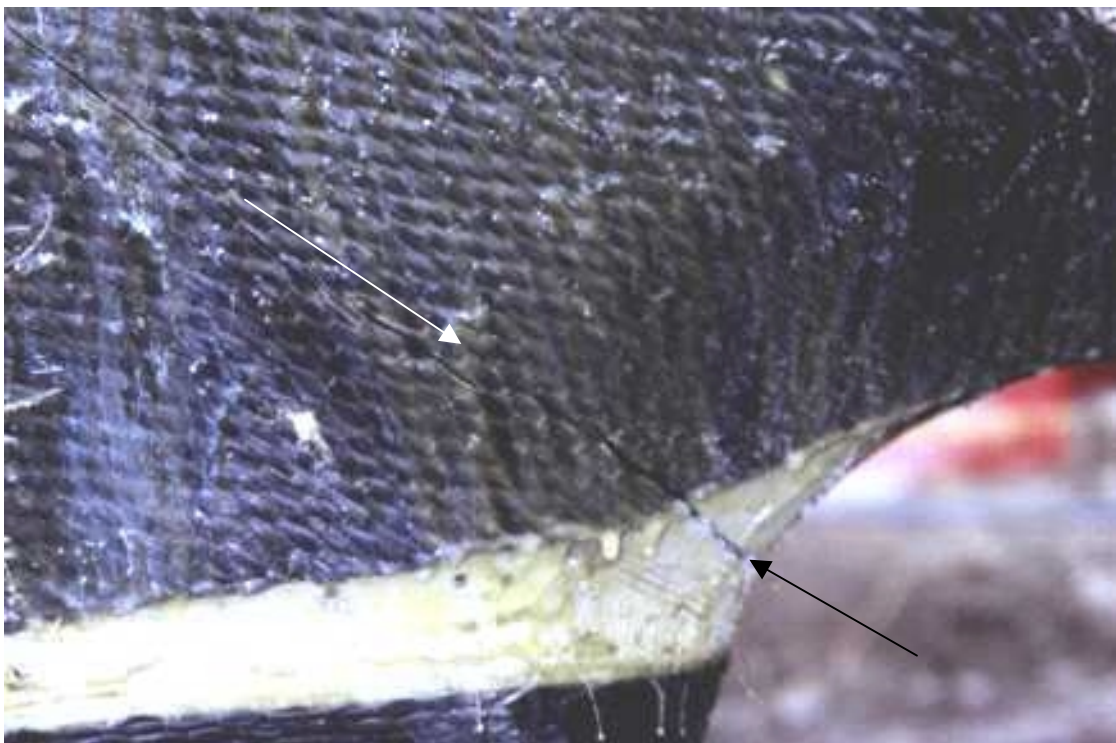
Figure 66. Cracks at the beam to column interface propagating into the FRP composite

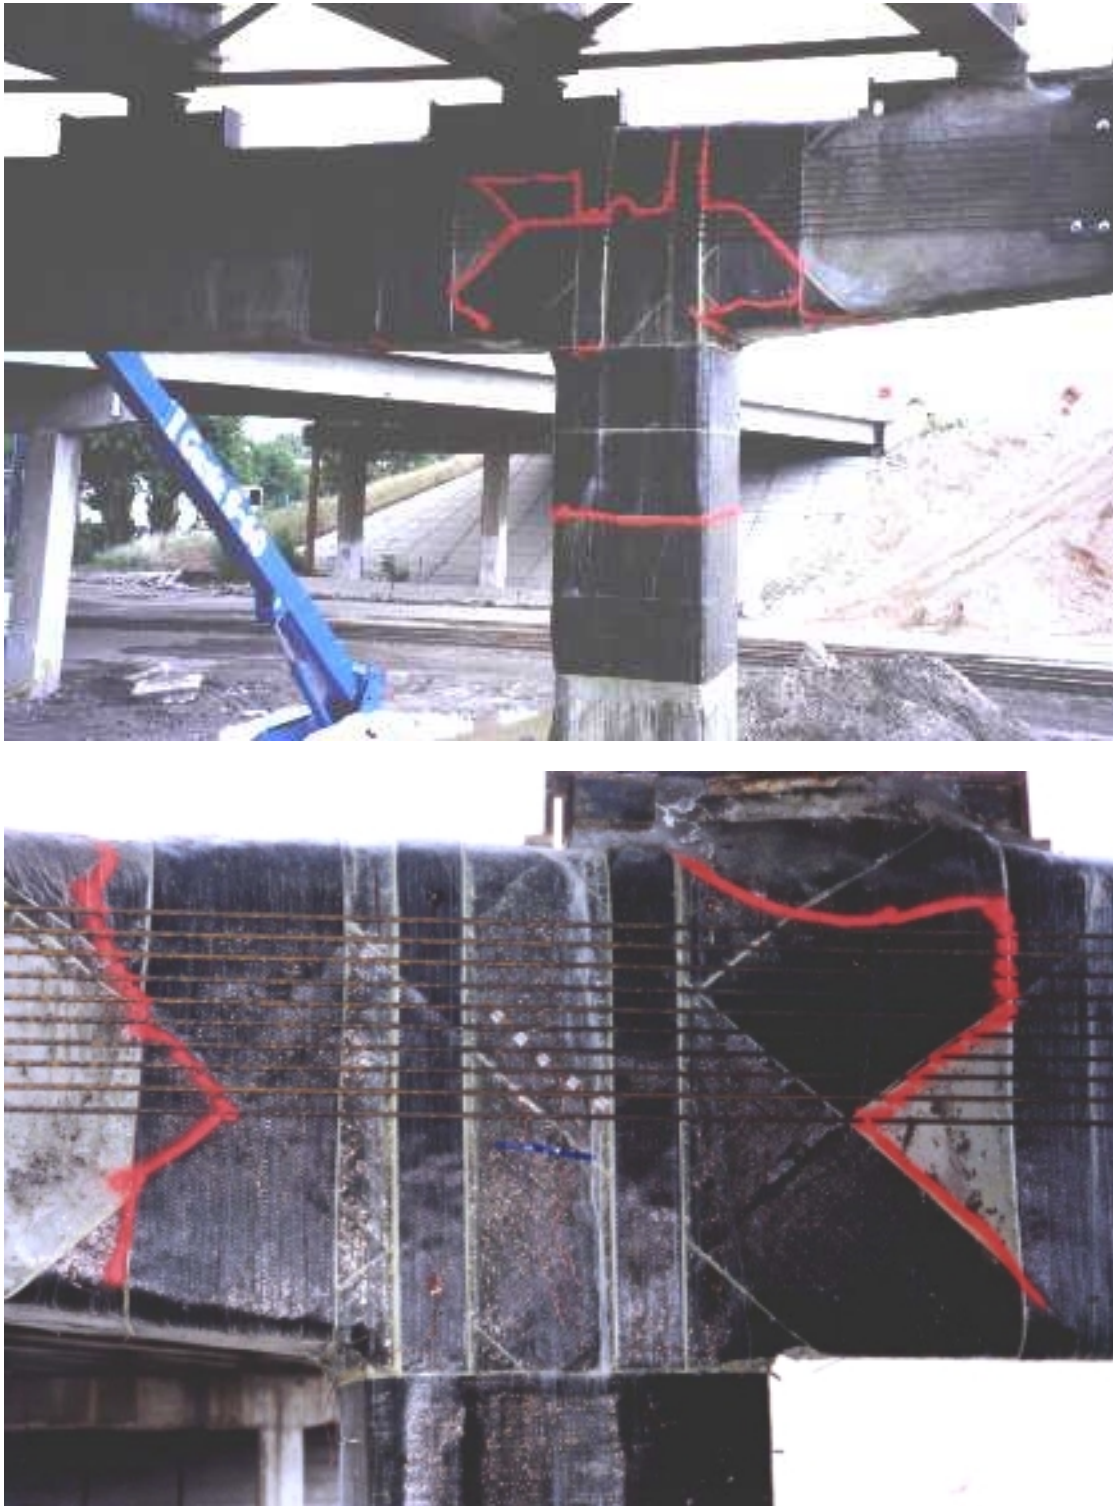
Figure 67. Delamination of FRP composite at the beam cap-column joints

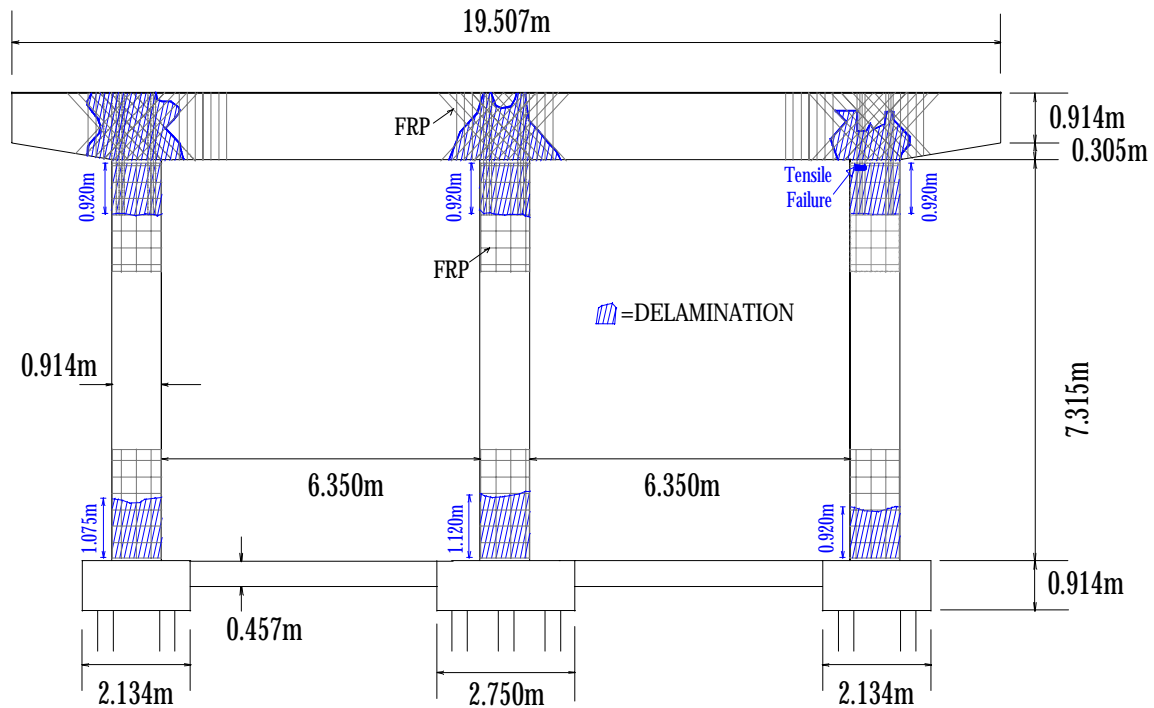
Figure 68. Delamination and tensile failure of FRP composite in Bent #6

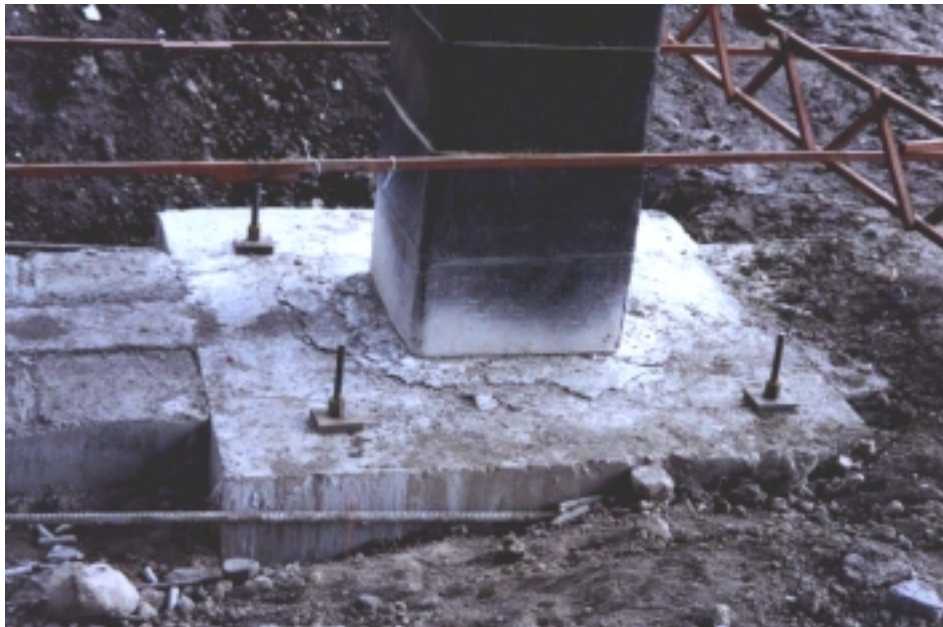
Figure 70. Radial and circular cracks at top of pile cap around the column

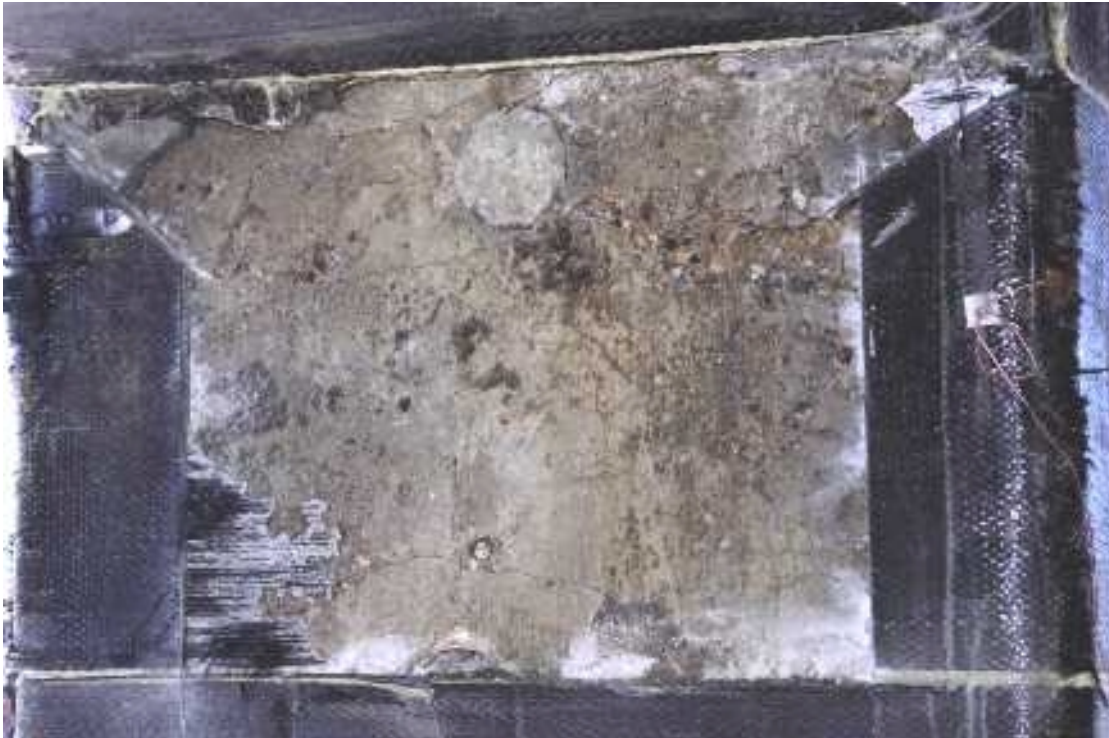
joints was also observed previously in laboratory experiments (Gergely et al. 2000). After completion of the test, the FRP composite was removed from the faces of the column, as shown in Fig. 71. It was found that the concrete had minor cracks, and the condition of the plastic hinge region was remarkably intact. It was found that the FRP composite confined the column and maintained its integrity even at the relatively high displacement ductility of $\mu_{\Delta} = 6.3$. This observation supports laboratory experimental evidence of the effectiveness of FRP composites to increase the ductility of concrete columns with relatively little concrete degradation (Priestley et al. 1996).

Figure 71. Condition of middle column below beam cap-column interface after removal of FRP composite at the completion of the test on Bent #6

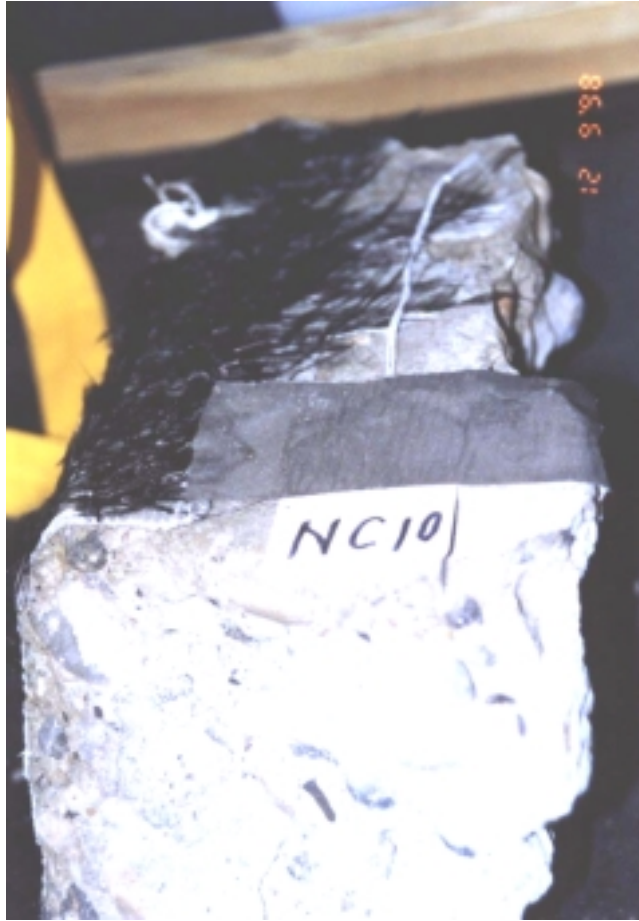
The quality of the FRP composite application and the FRP composite material itself was examined after the test on Bent #6 after demolition. For the most part the saturation of the fibers was good even though some dry fibers were occasionally found as shown in Fig. 72. The use of a saturator would alleviate this problem. The bonding of the FRP composite to the concrete substrate was varied. Even though the old concrete was removed and shotcrete was applied in the beam cap, there were still areas where the FRP composite delaminated with little resistance from the substrate concrete. However, in most areas a sufficiently good bond was observed as shown in Fig. 72. The water jet procedure is recommended after application of shotcrete for an even better bond. This is critical in areas such as the beam cap-column joint where the FRP composite contribution depends on the bond between concrete and FRP composite.

Figure 72. Condition of FRP composite and adhesion of FRP composite to the concrete

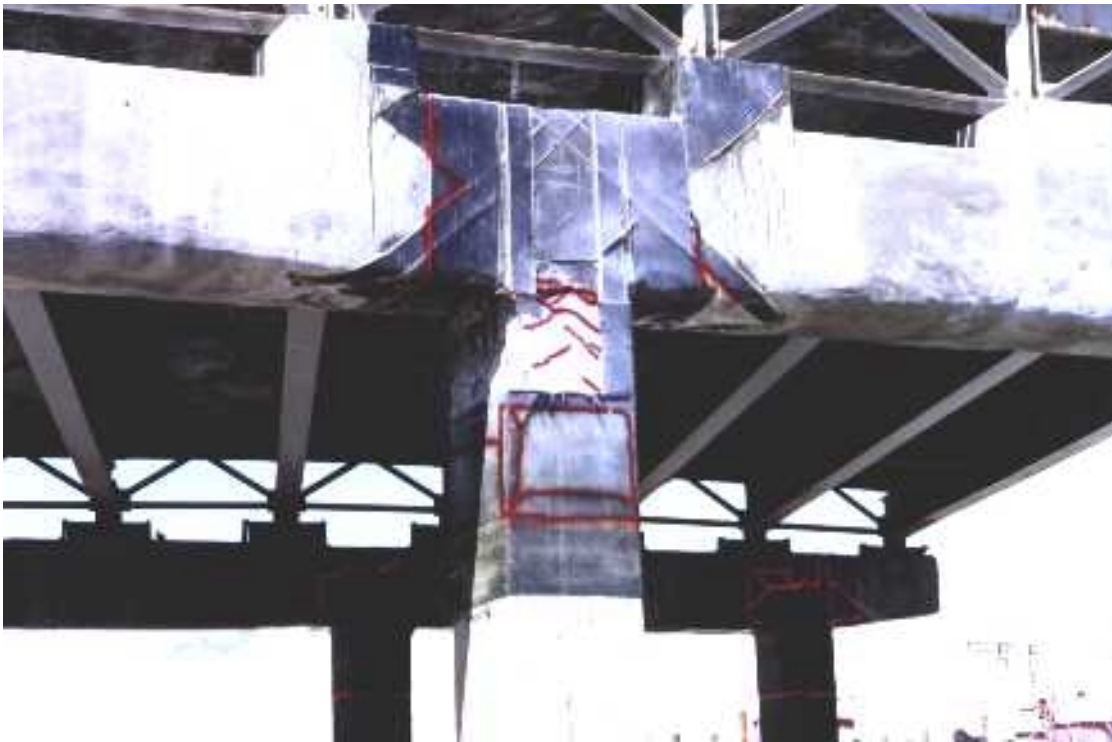
Figure 97. Diagonal cracks in plastic hinge region at the top of the middle column underneath the FRP composite

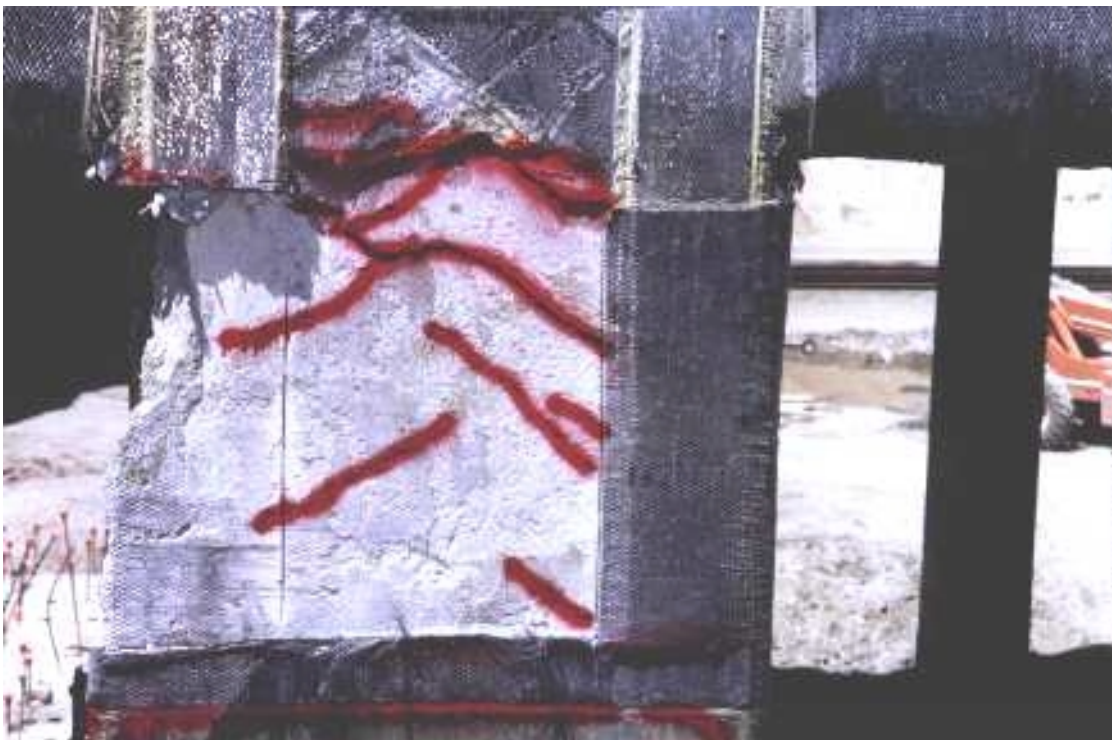
Figure 98. Close up of diagonal cracks in plastic hinge region of column

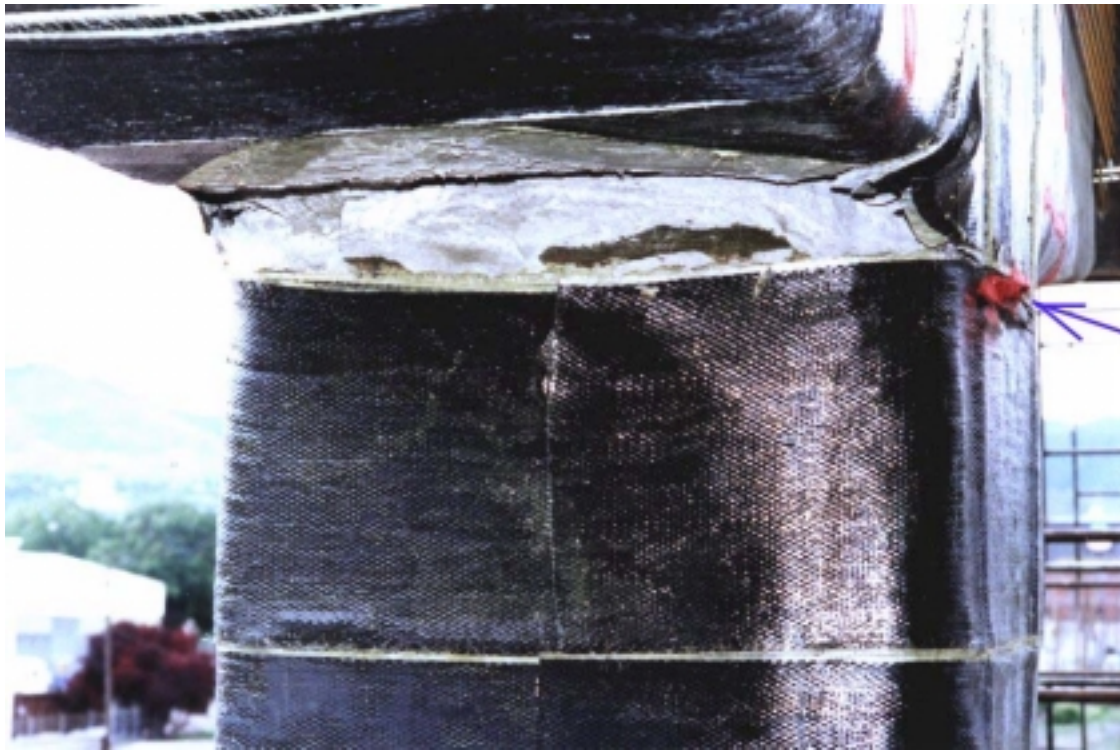
Figure 99. Tensile failure of FRP composite in U strap at the column

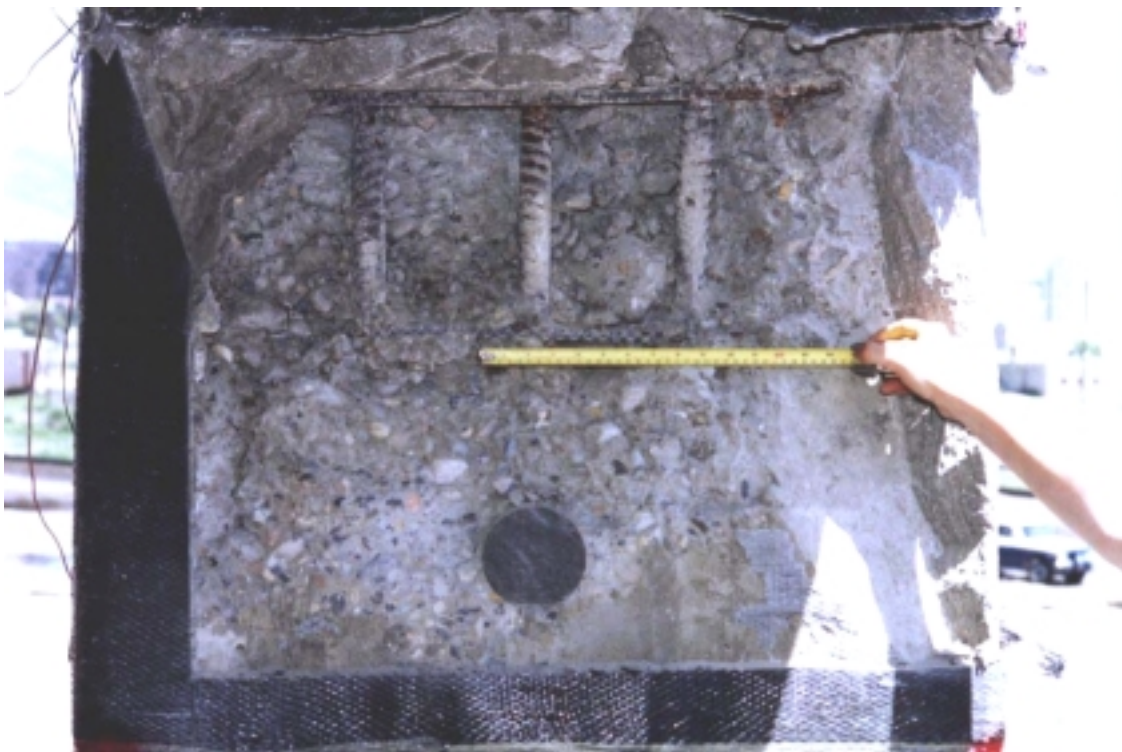
Figure 100. West-facing view of top of middle column after FRP composite was removed

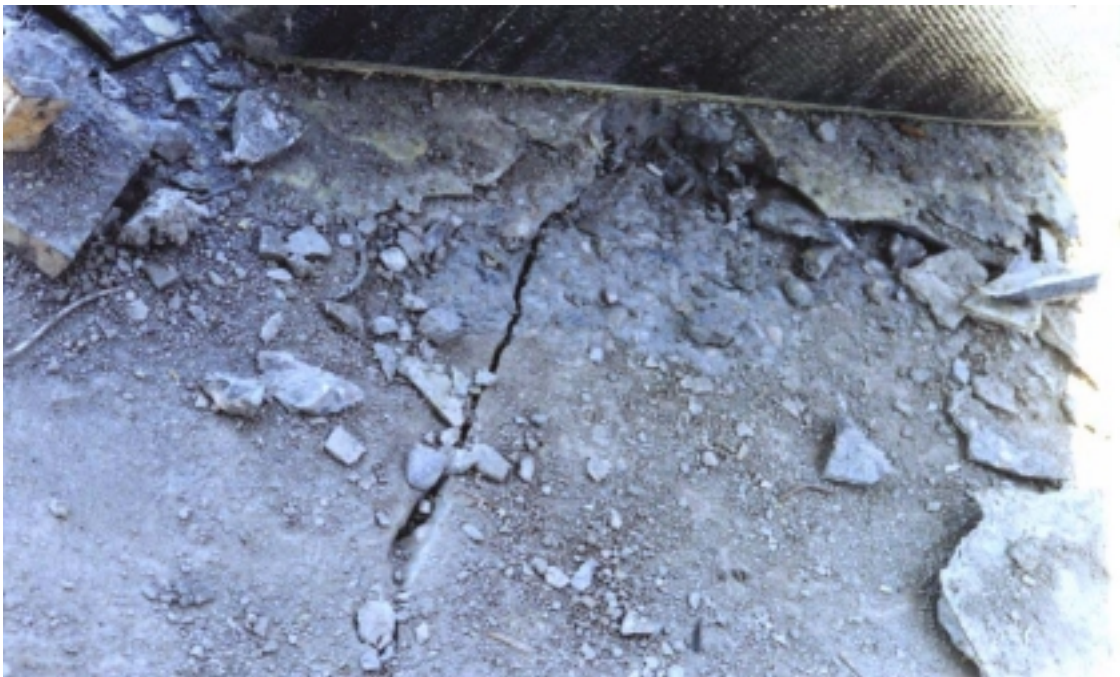
The connection of the piles to the pile cap using 32 mm Dywidag bars shown in Fig. 10, was able to transfer the loads to the piles effectively with the development of radial cracks forming at the last load cycles as shown in Fig. 103. After demolition, the pile portion with the Dywidag bar was removed from one pile cap and the connection was examined. As Fig. 104 shows, the four #6 (19 mm) bars had buckled, the 32 mm Dywidag had yielded and was bent, and the anchor plate was also damaged. The rigid link beam between the pile cap and the footing shown in Fig. 12 as section B-B, suffered severe damage and extensive cracking as shown in Fig. 105; however, this did not occur until the last few cycles of the test.

Figure 103. Radial cracks at pile cap surface of Bent #5R

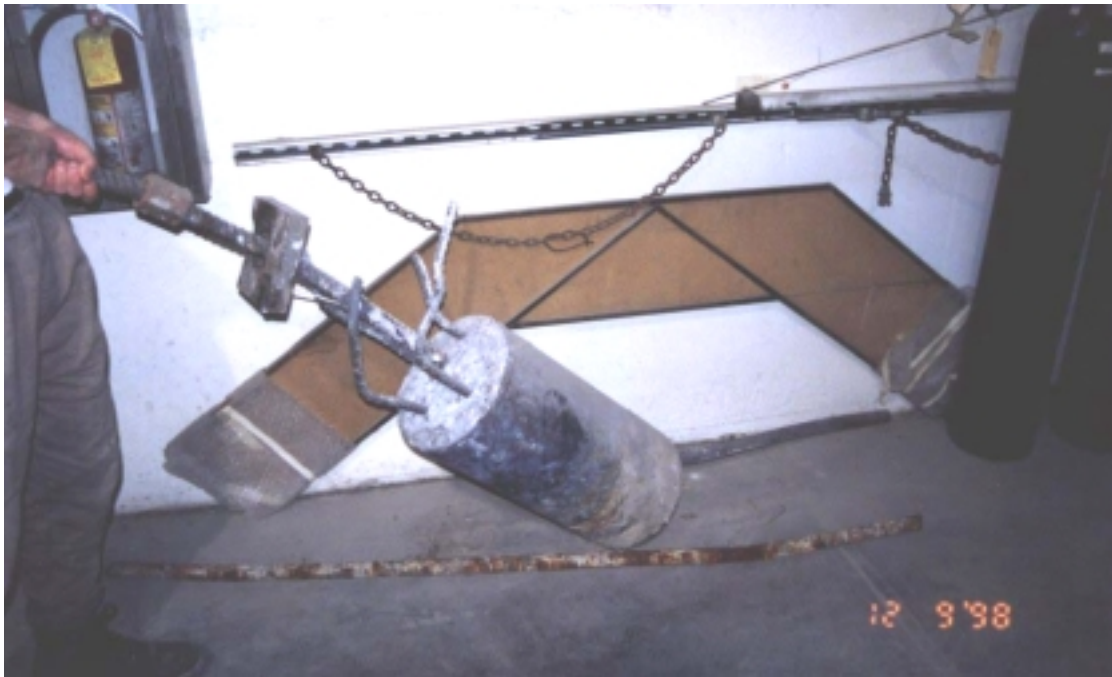
Figure 104. Damage of pile-to-pile cap connection

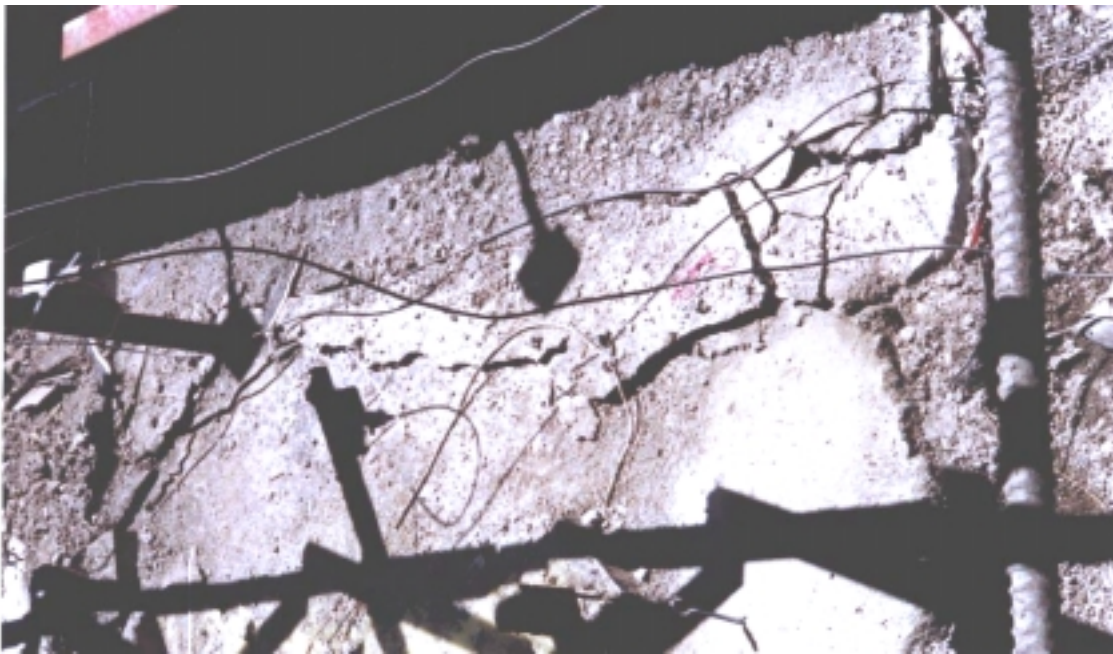
Figure 105. Damage in rigid link beam between pile cap and load frame footing

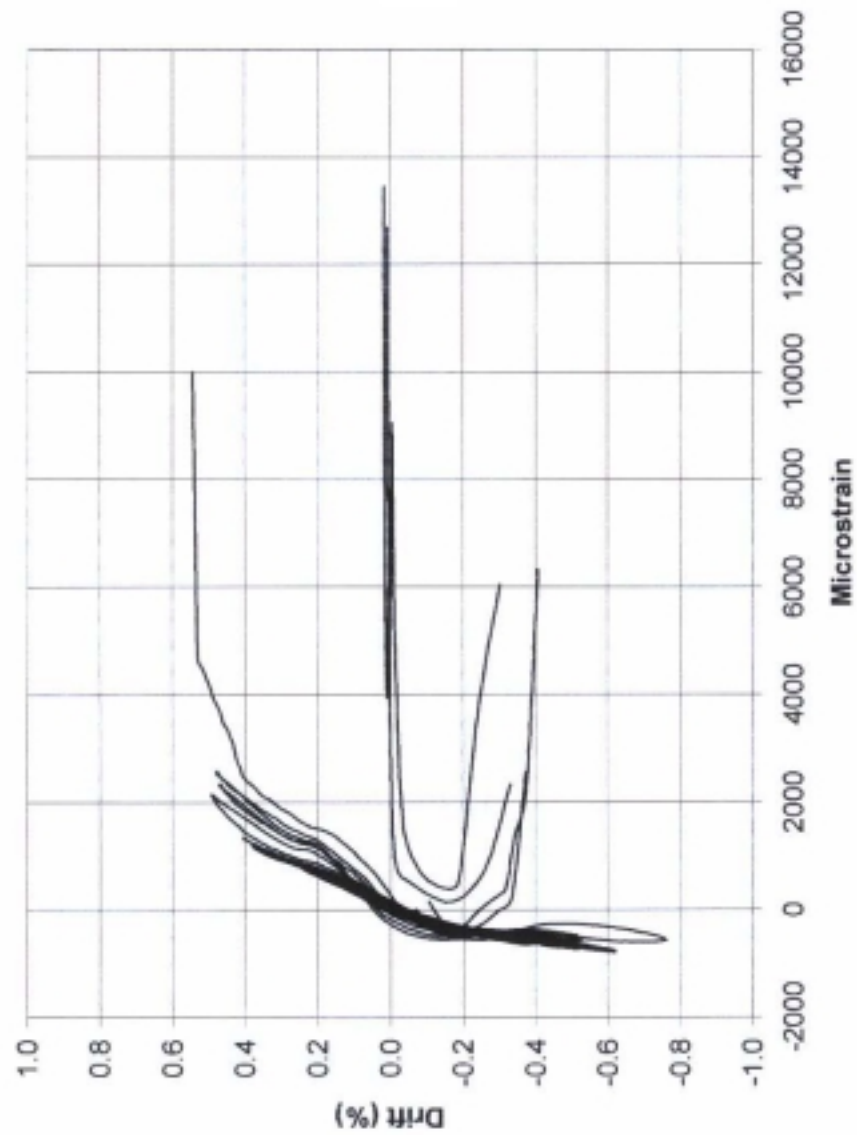
Figure 112. Column bar slippage at top of center column
